**APPENDIX F – WATER BODY AND WATER ASSESSMENT  
REPORTS**

## ***Nation Rise Wind Farm*** **Water Body Assessment**

Prepared for:  
DNV-GL - Energy  
4001 Rue Molson, Suite 100  
Montréal, QC  
H1Y 3N1

Project No. 1756 | August 2017

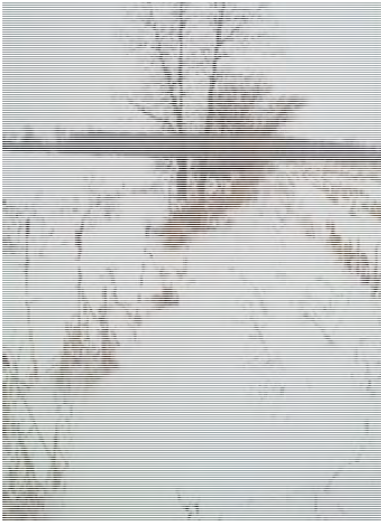
Stark and Branches Municipal Drain	WB-117	Downstream, Looking West

Stark and Branches Municipal Drain	WB-117	493791	5002015	11/Feb/17	5	3	100	-12	None	Straight	Defined	L	0.3	2.5	15.3	15.3	1.8	Unknown	Terrestrial grasses, cattails, deciduous trees and shrubs	Moderate Slope, High Stability	L	Cattail throughout reach	80% Broad-leaved Cattail and 20% terrestrial grasses	Unknown	L	Clear	Unknown	Unknown	Unknown	Unknown	None observed	Y	Intermittent	None	Channelized drain originating at a tile drain outlet, some terrestrial grasses observed, mainly Broad-leaved Cattail visible beneath the snowpack, open water present at tile drain outlet, feature becomes frozen and snow covered several meters downstream of the outlet
		Alex Rutley Municipal Drain	WB-122	490689	5001434	03/Feb/17	0	2	50	-8	None	Straight	Poorly defined	L	2.5	4.0	Unknown	Unknown	Unknown	Silt	Terrestrial grasses, deciduous shrubs, and broad leaved cattails	Moderate Slope, Moderate Stability	L	Terrestrial grasses and cattails throughout	50% terrestrial grasses and 50% Broad-leaved Cattail	0.5	L	Brown	None visible	None observed, most of the surface is frozen	None observed	Duckweed sp.	Y	Intermittent	1.0m CSP north of point (downstream)	Channelized drain with Duckweed sp. and Broad-leaved Cattail suggests a degree of permanence, while terrestrial grasses on stream bed suggests periods of dry conditions
