ESS Group, Inc. (ESS) has prepared a preliminary assessment of the potential Over-Size/Over-Weight (OS/OW) truck routes for the Marble River Wind Project. This report describes and evaluates potential routing to the site, describes and evaluates local transportation routes within the site boundaries, identifies potential transportation route deficiencies, outlines tasks required by outside agencies and contractors, and identifies NYSDOT permits required before the work can be performed. At the time this report was prepared, the general project area and some of the wind turbine locations were identified but specific wind turbine siting information was not available. The exact transportation routes to the turbine sites have not been identified and will be refined as turbine locations are finalized. Therefore, all local area road intersections that could potentially be used were visually inspected to identify possible construction vehicle maneuvering difficulties.

MARBLE RIVER WIND PROJECT
 Preliminary Transportation Assessment
 Clinton County, New York

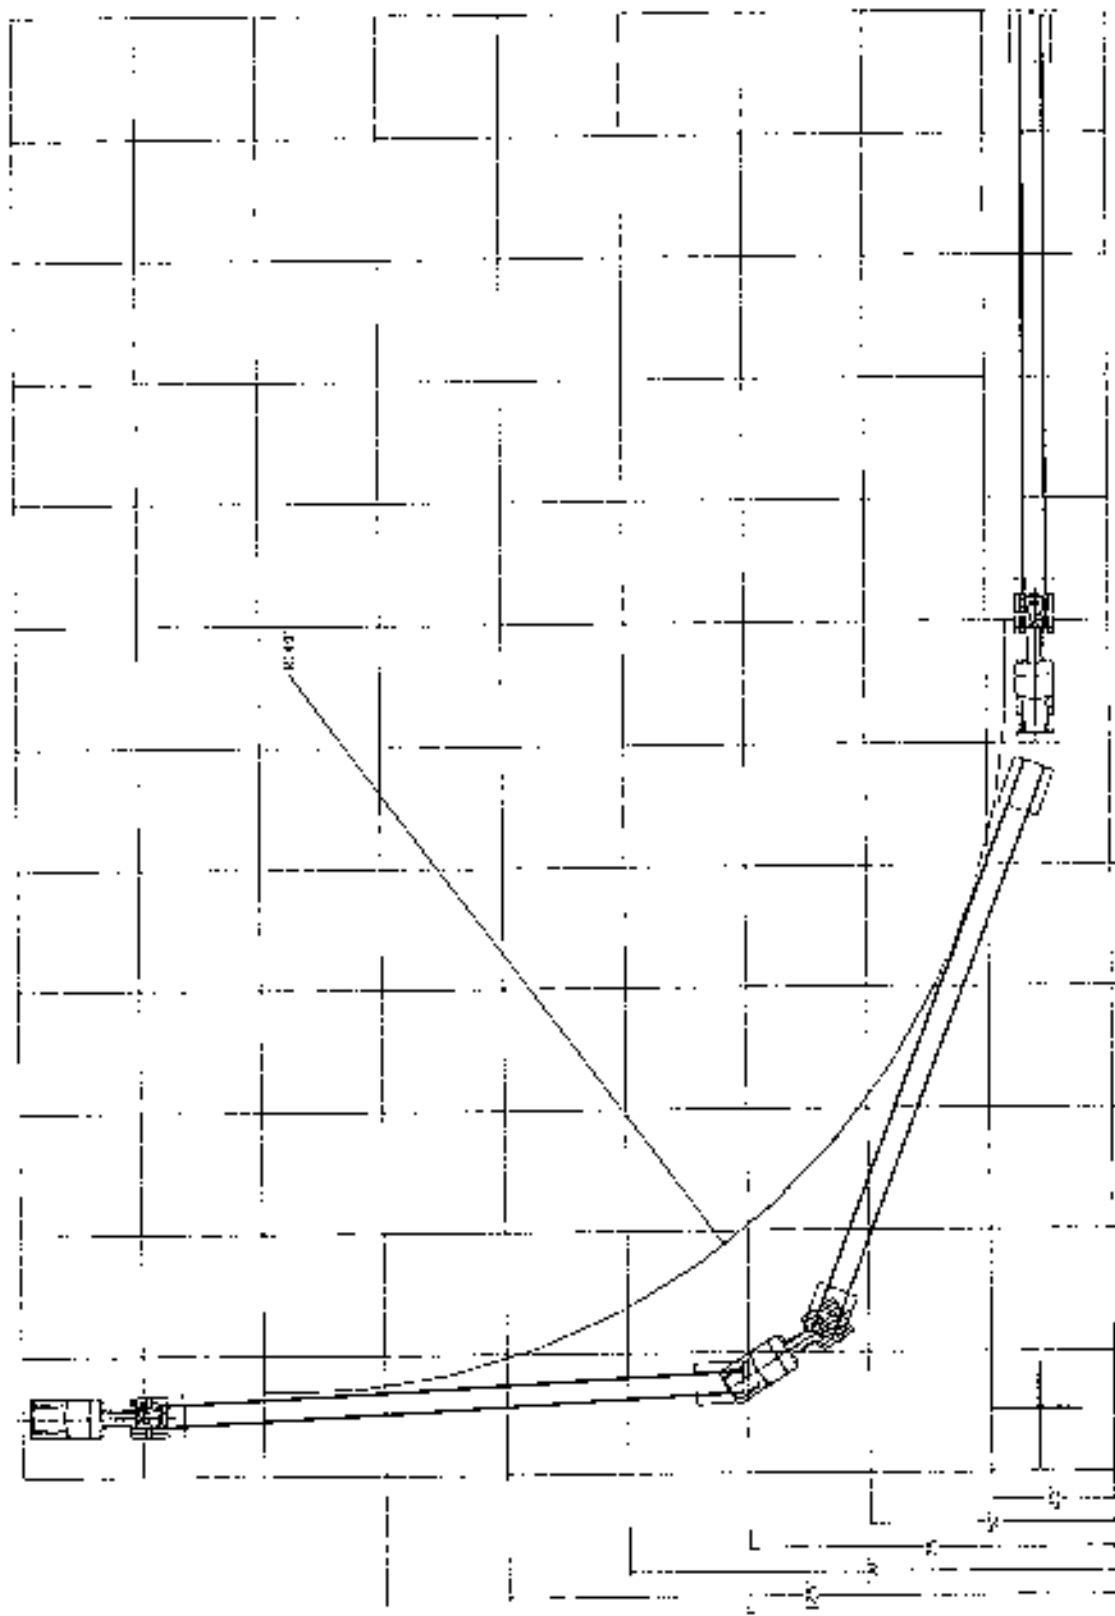
APPENDIX A:
Figure 3

Project	Country	Initial Name	Designation	Project No.	Scale
PROJECT NAME					
Designed by	Checked by	Approved by	Project No.	Scale	Sheet No.
TURNING RADIUS FOR M510					
PROJECT NO. M510					
SCALE: 1/1					
SHEET NO. 1/1

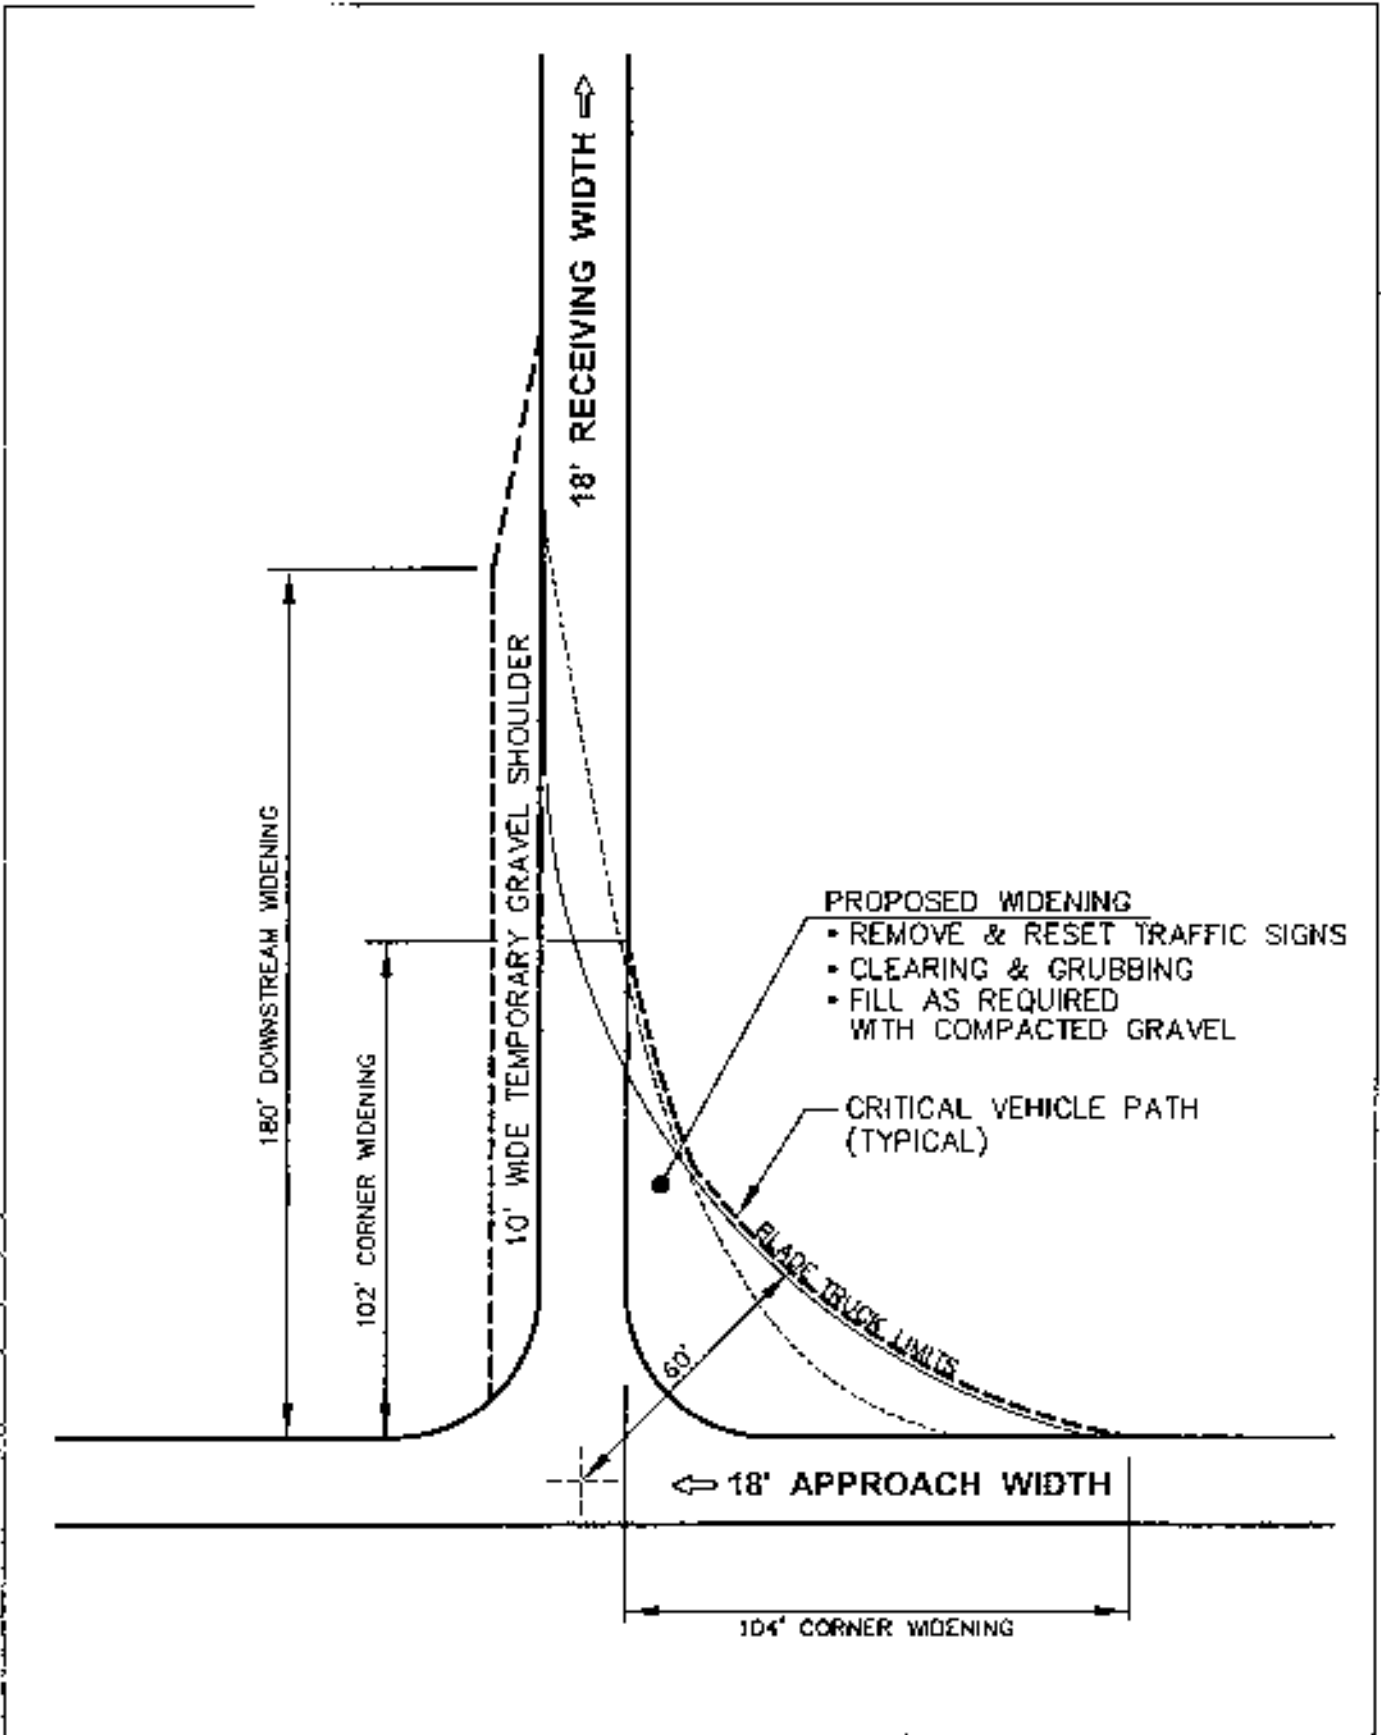
Figure
 7

APPENDIX A:
Intersection Improvements
Downstream / Corner Widening
Local & County Roads

INSUFFICIENT INTERSECTION GEOMETRY. This is the single most common problem observed in the field. Almost all of the 3-way and 4-way intersections have 90-degree tight-radius intersections with obstacles present on the inside corners such as traffic signs, utility poles, and drainage culverts. Often times there is also a significant difference in grade between the road (higher elevation) and the adjacent ground (lower elevation) on the inside corner. See Potential Mitigation Techniques.

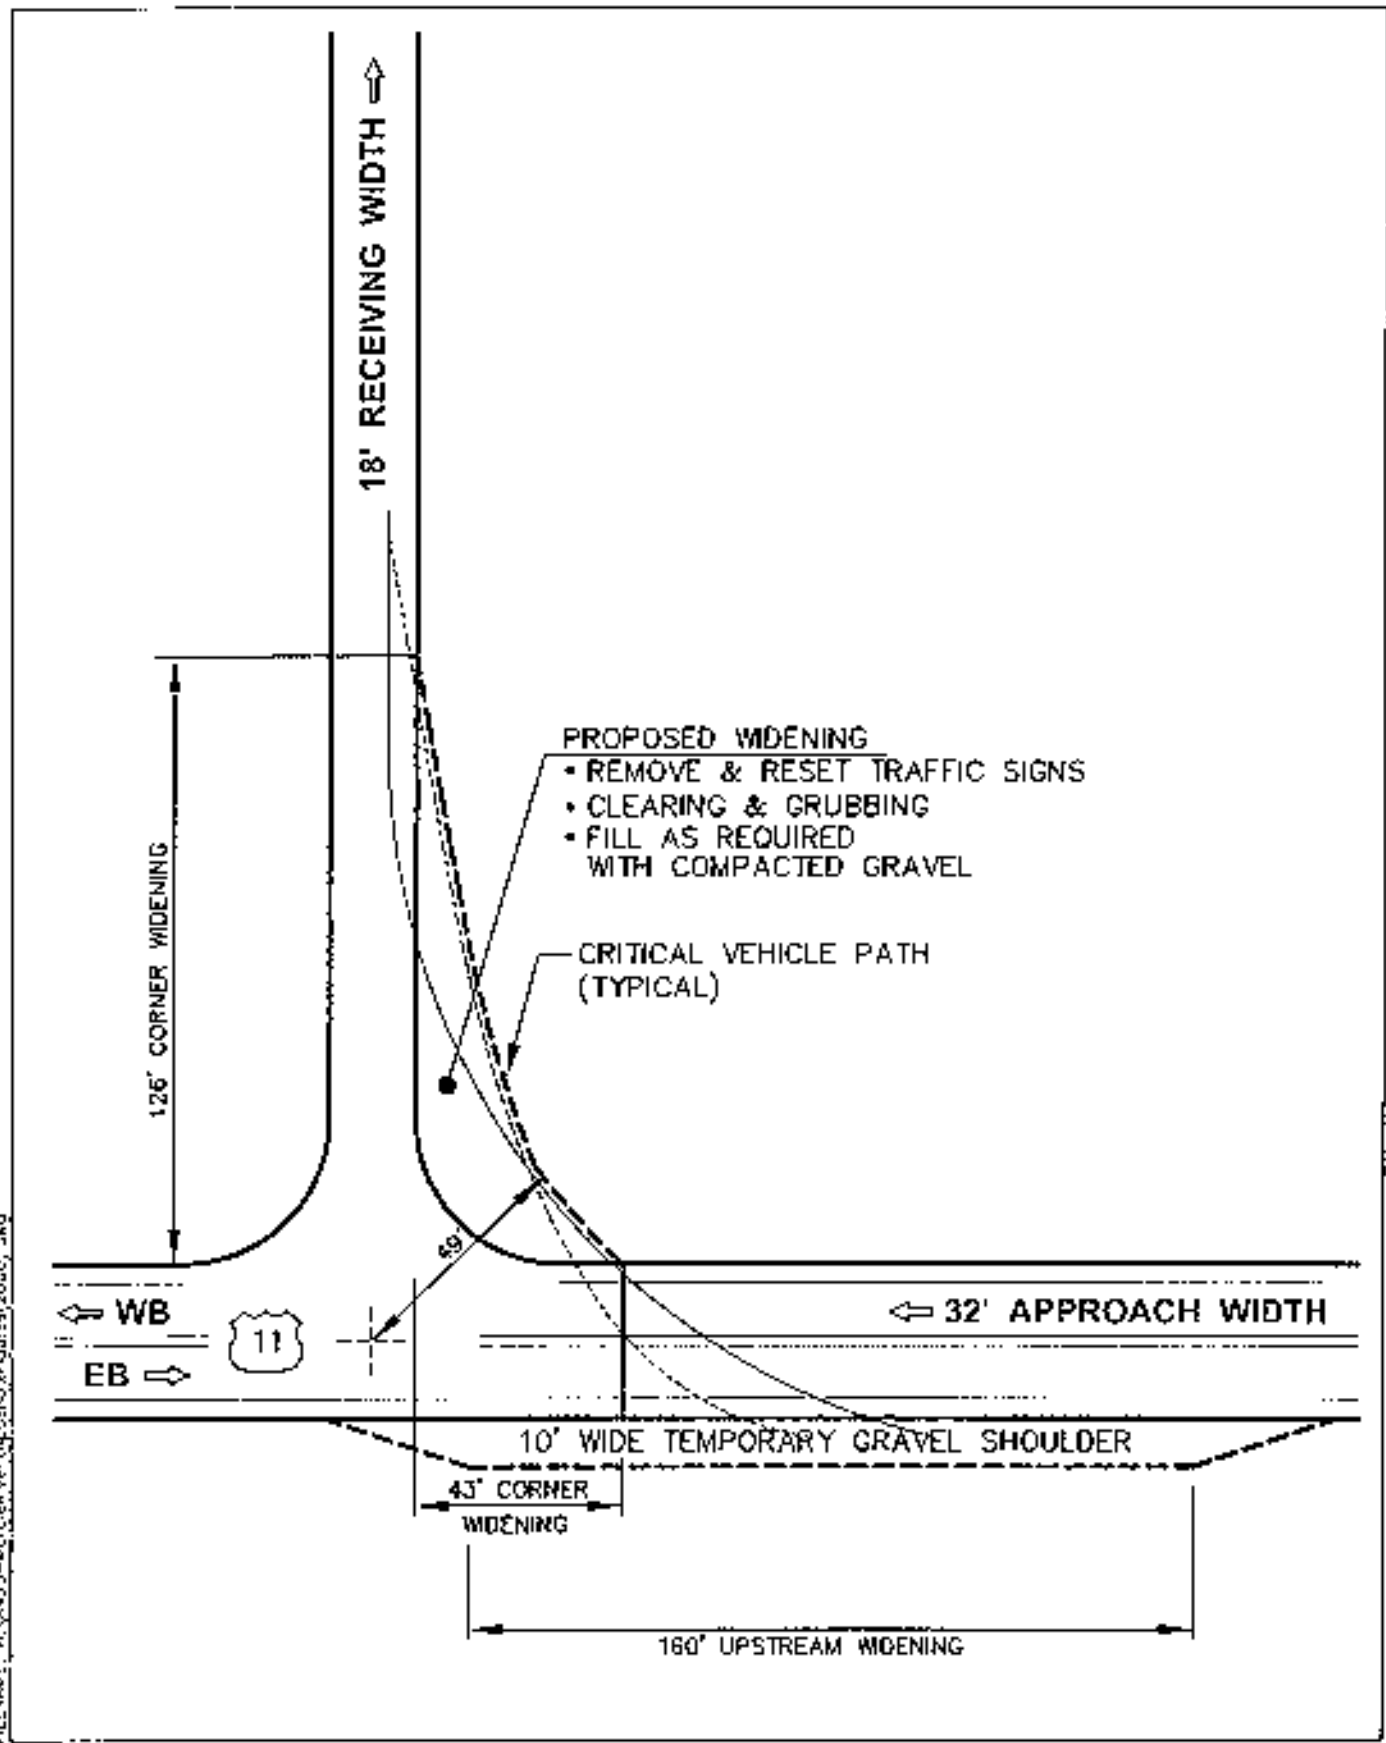
APPENDIX A:
Intersection Improvements
Upstream / Corner Widening
Local & County Roads

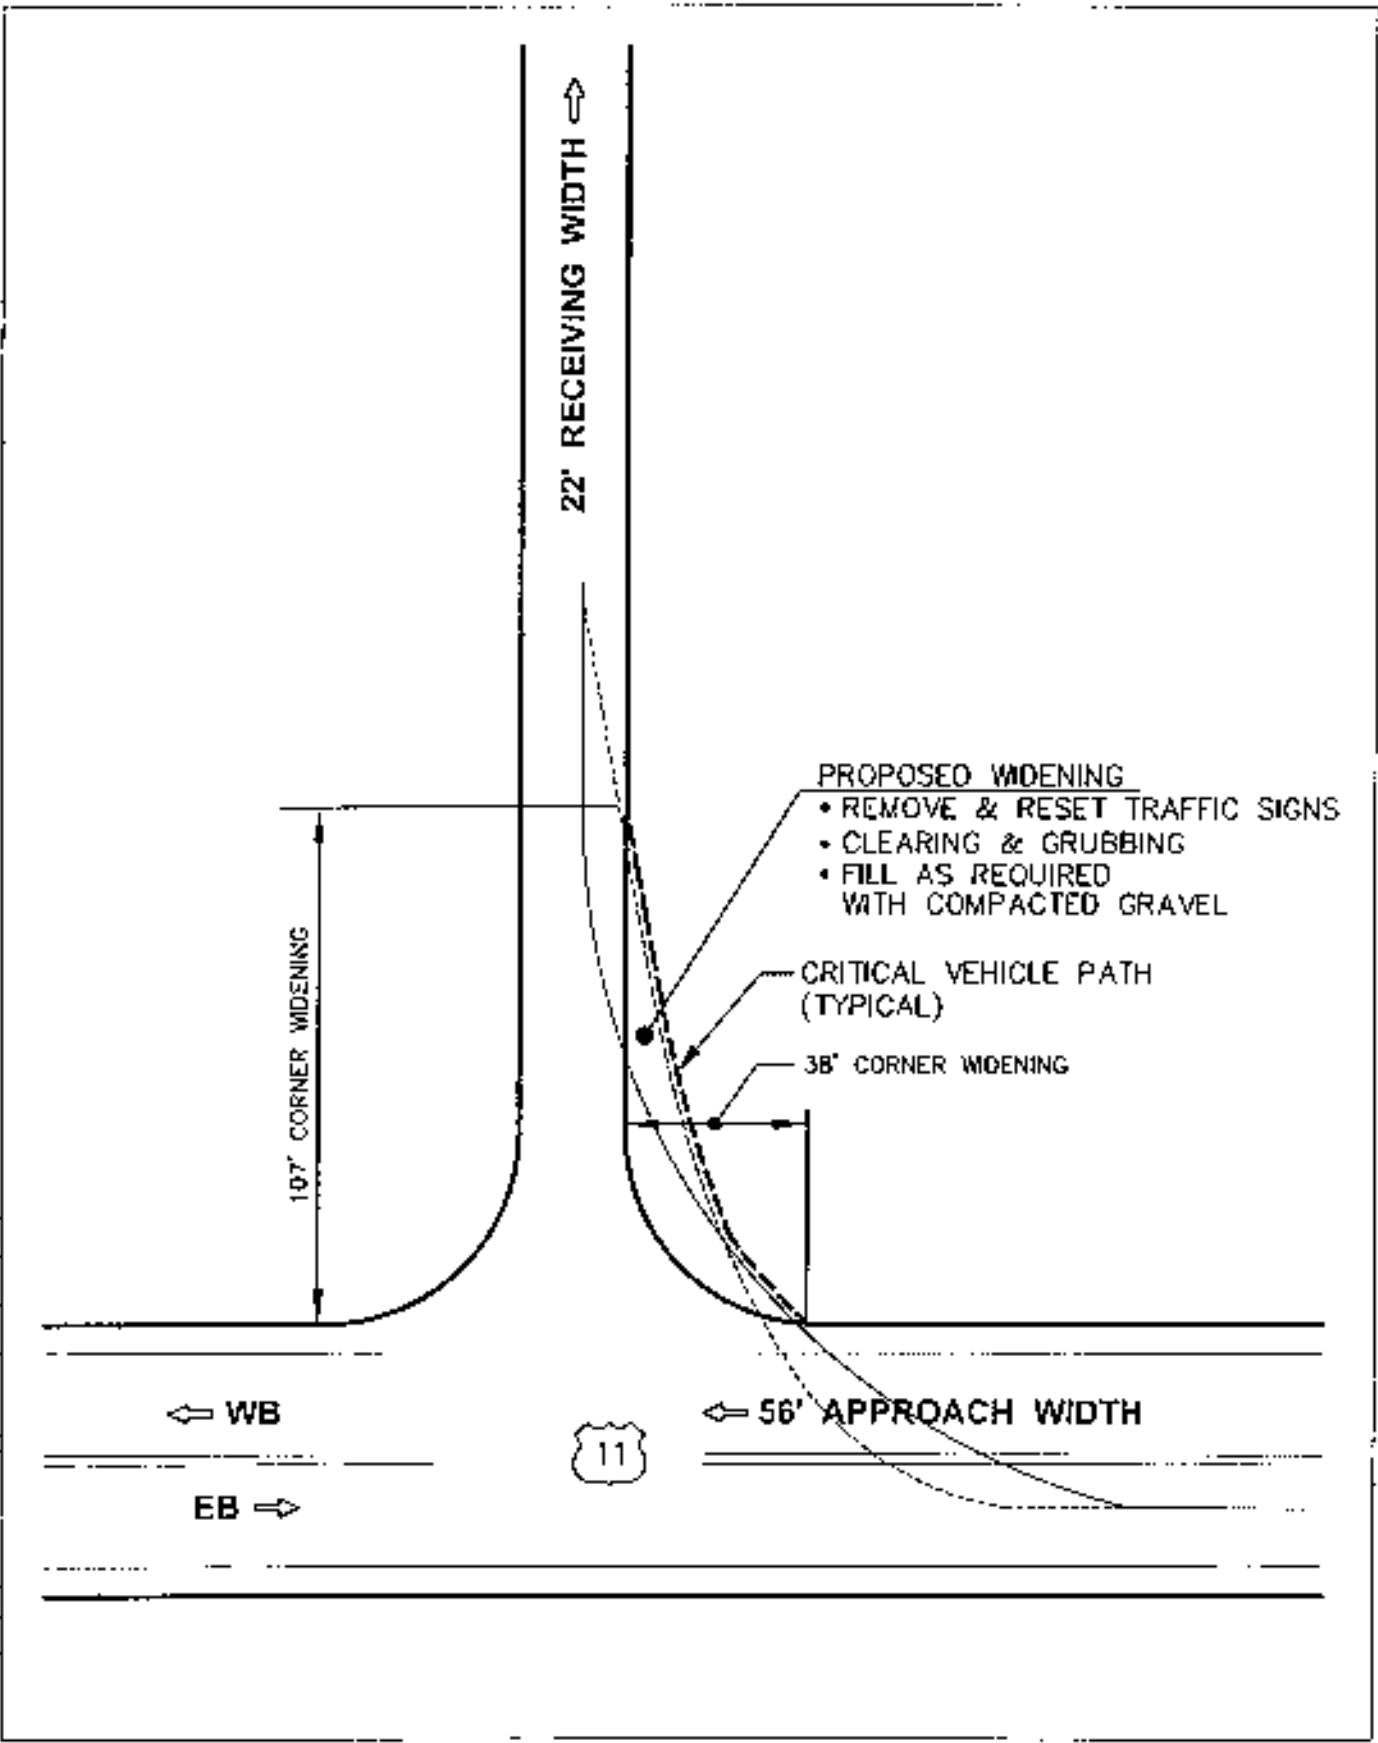
Figure
10

APPENDIX A:
Intersection Improvements
Corner Widening Only
Local & County Roads

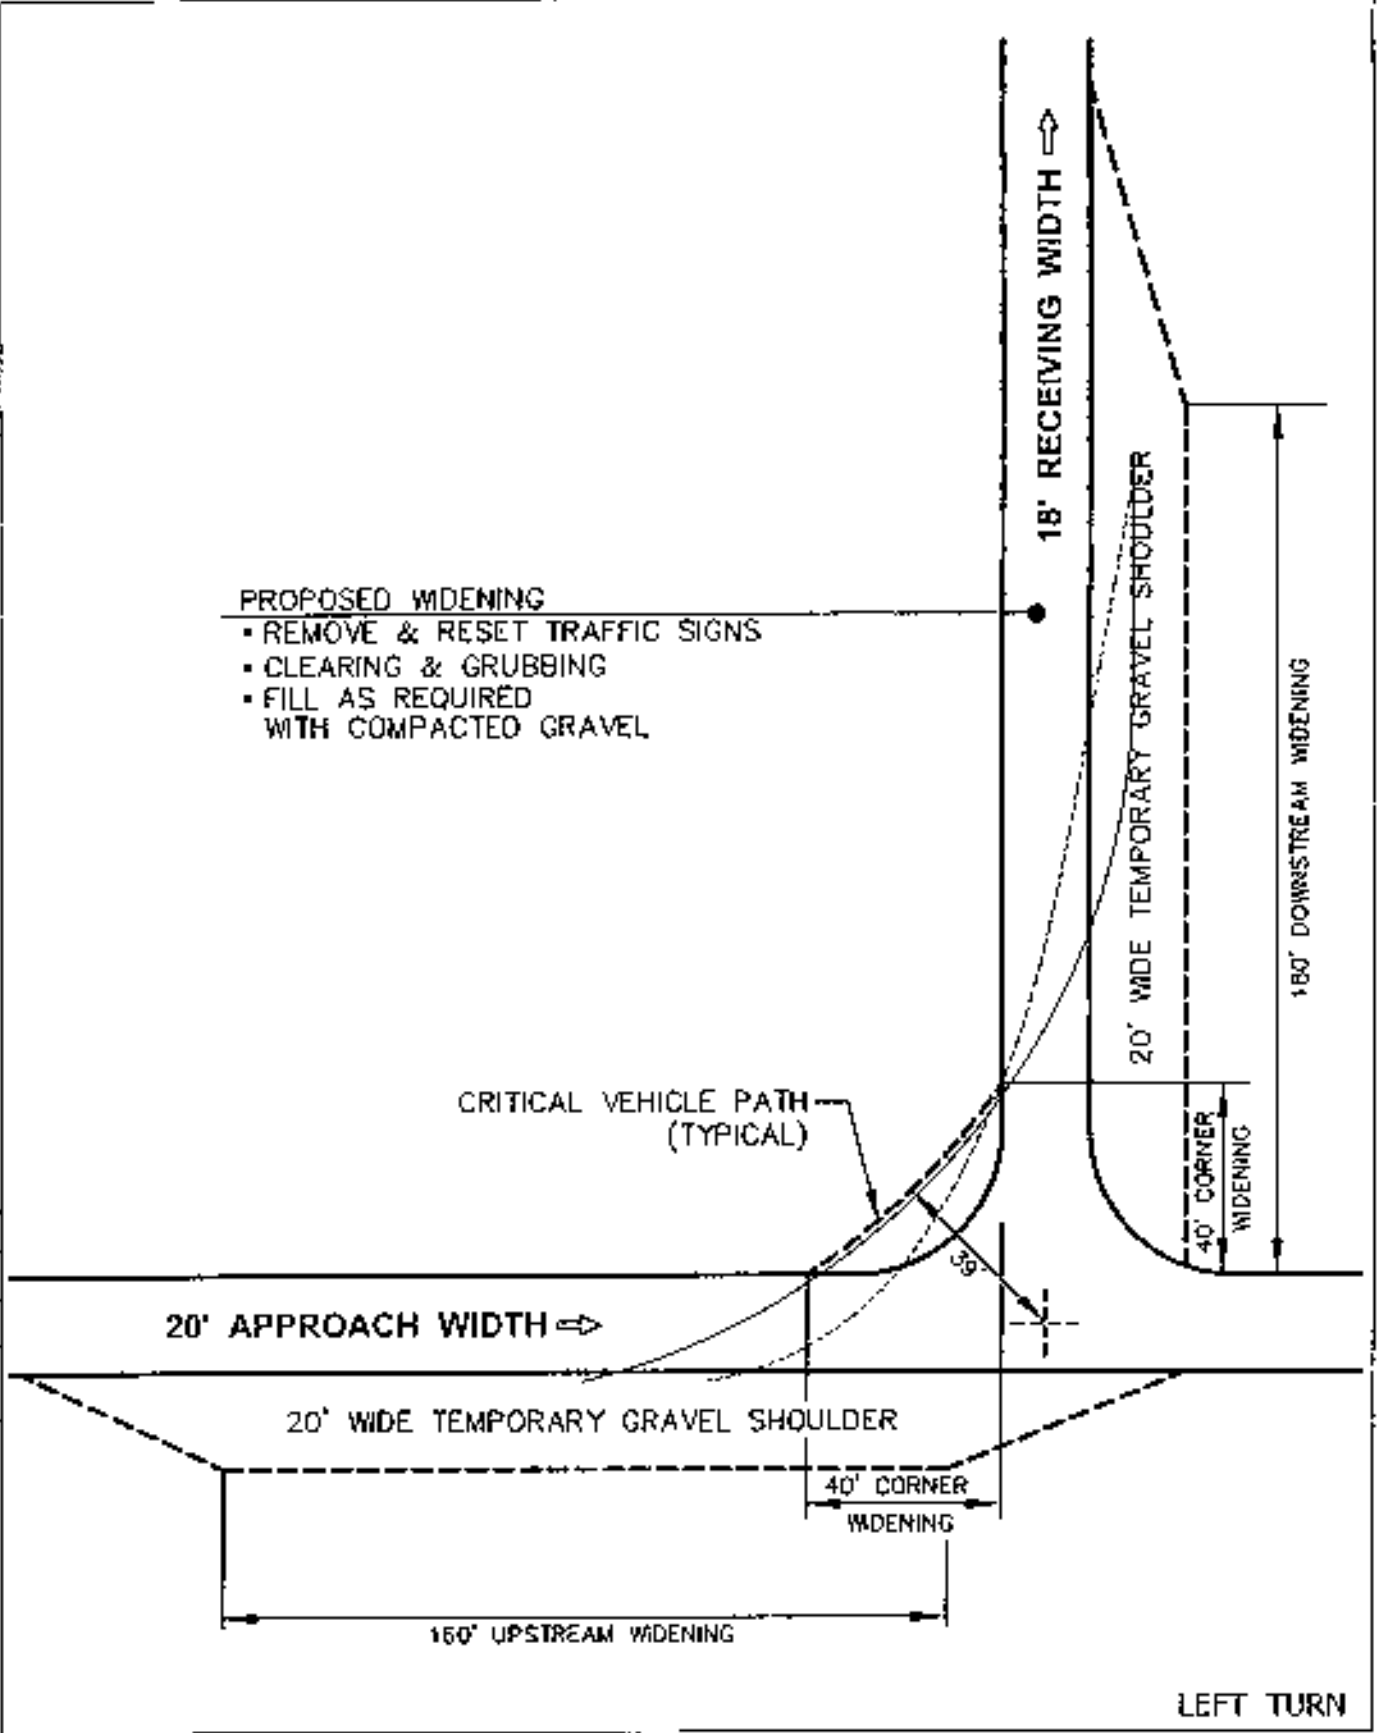
Figure
 12

APPENDIX A:
 Intersection Improvements
 Upstream / Corner / Downstream
 Widening: Local & County Roads

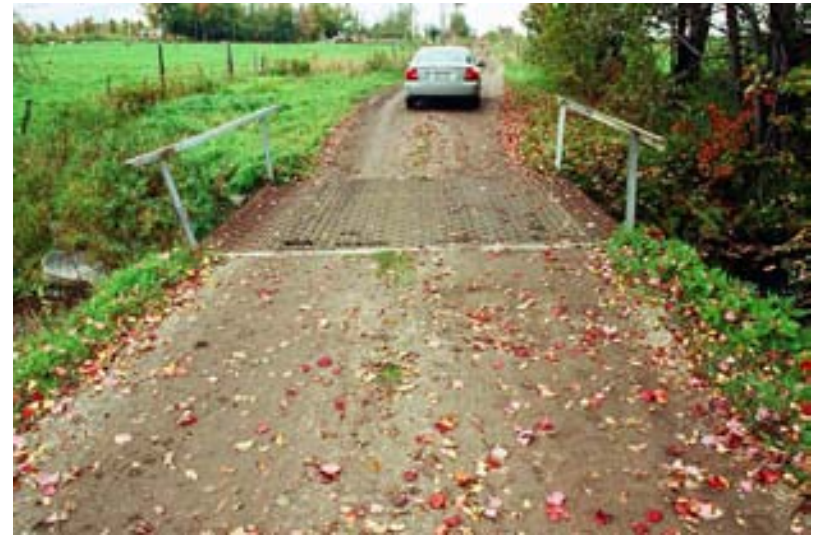
3d. Soucia Rd. – Steel grate bridge

LOCAL ROAD	MILE	DESCRIPTION
SR 189	5.5	Concrete bridge over brook. Check with NYSDOT for BIN
SR 189	5.0	Concrete bridge over brook. Check with NYSDOT for BIN
LOOBY RD	0.6	Concrete bridge over brook. Check with CC Hwy. Dept
CLINTON MILLS RD	4.0	Concrete bridge over stream. Check with CC Hwy. Dept.
BOHEN/CAMPBELL	2.7	Concrete bridge over brook. Check with CC Hwy. Dept
BOHEN/CAMPBELL	3.9	Concrete bridge over brook. Check with CC Hwy. Dept
SOUCIA RD	0.01	Steel grate bridge over stream. Unsafe. Do not use.
